1. INTRODUCTION

STS-71 was the Shuttle's first docking mission with the Mir station. Approximately 670 photographs and 24 hours of video of the Mir station were acquired during the rendezvous. This report documents results from several survey-related analysis tasks.

1.1 Overview of Mir Photo/TV Survey

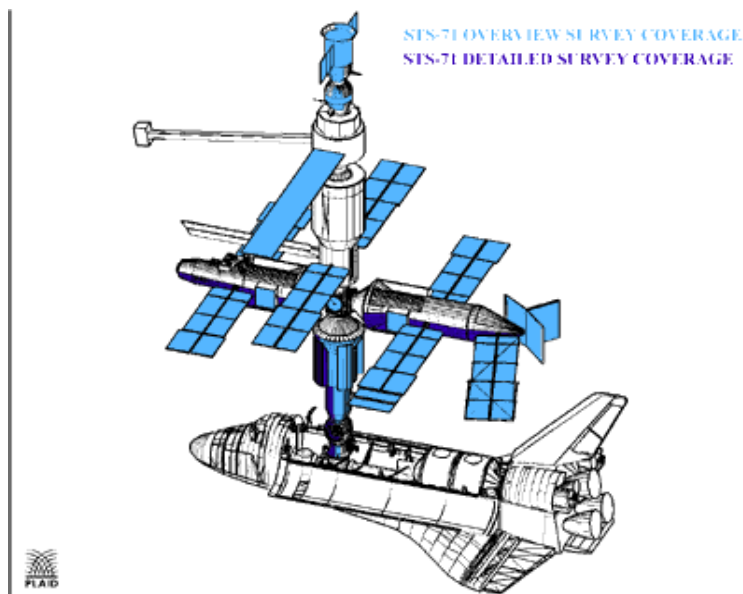
Figure 1-B STS-71 Mir Survey Coverage (Top View)

Note that none of the solar arrays are classified as having been covered in detail. This is primarily due to the fact that limited detailed coverage of the solar arrays has been obtained due to panel orientation, lighting conditions and crew time constraints. However, Orbiter-facing sides of the Kvant-2 and Spektr modules were imaged in detail on this mission.

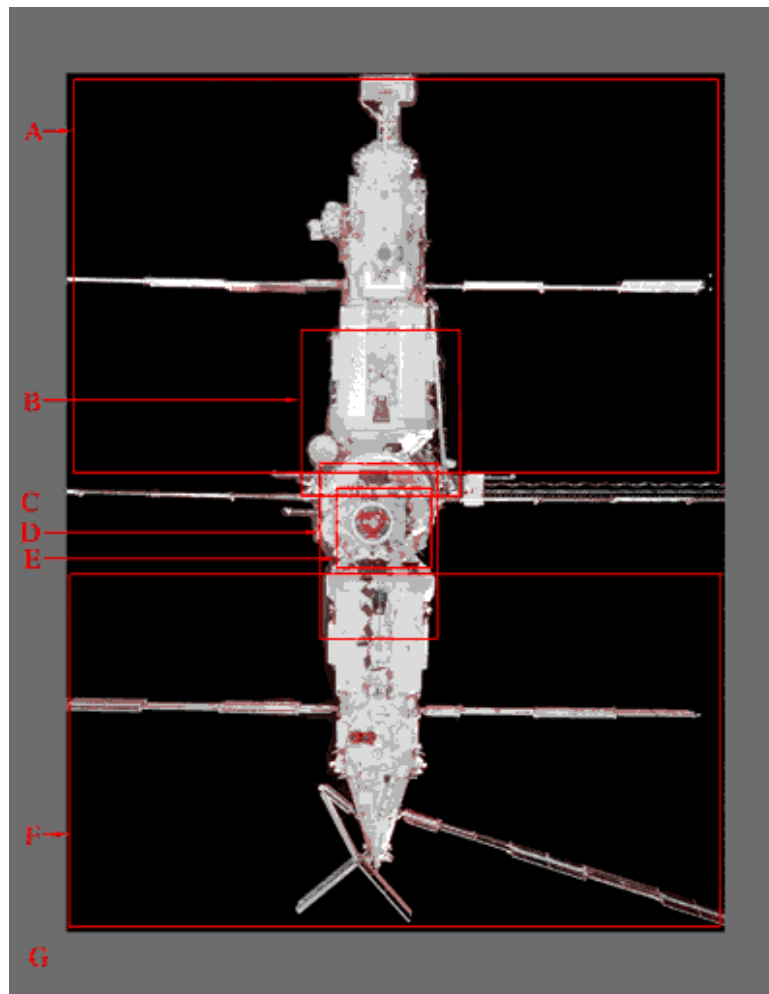
Figure 2 Mir Station during Approach (Mosaic View)

The boxes labeled A - G encompass regions whose exterior surfaces are described in detail within this section. Boxes C and G are regions which are not observable in this view. Kvant-2 (A and B) was the second module to dock with the Mir base block. It's primary purpose is to support extravehicular and remote sensing activities. Part of box B and all of

C refers to the Kristall module. This module is used for material processing, remote sensing, and vehicle docking. The docking module (D and E) has two androgynous peripheral docking units (E). Box F identifies the Spektr module. This module is the latest addition to the Mir station. It's primary objective is to study the environment and the earth's atmosphere. Box G refers to the Soyuz TM. The Soyuz capsule is used to transport cosmonauts and astronauts between Mir and earth. During STS-71, Soyuz was used to document the undocking of the Shuttle from the Mir.

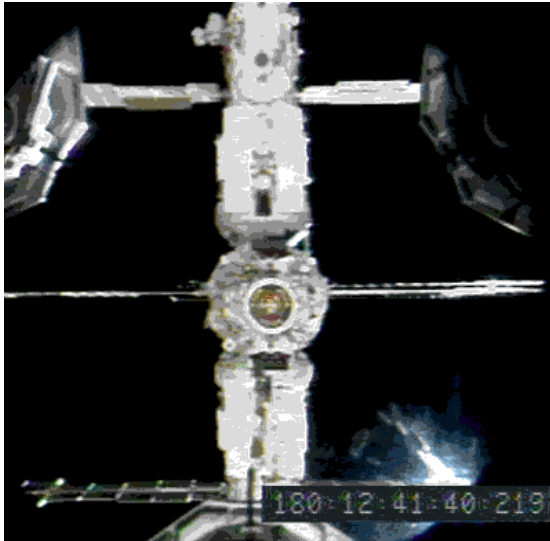
Figure 4-A ODS Approach View

Since the primary function of the ODS centerline camera was to provide the crew with a means to visually align the target during approach, a zoomed-out configuration was used to provide the widest field-of-view. Sun glare, visible on the bottom right corner of the image, severely hampered analysis during the latter stages of approach. From the image in Figure 4-A, one can verify the feathered configuration of the Mir arrays.

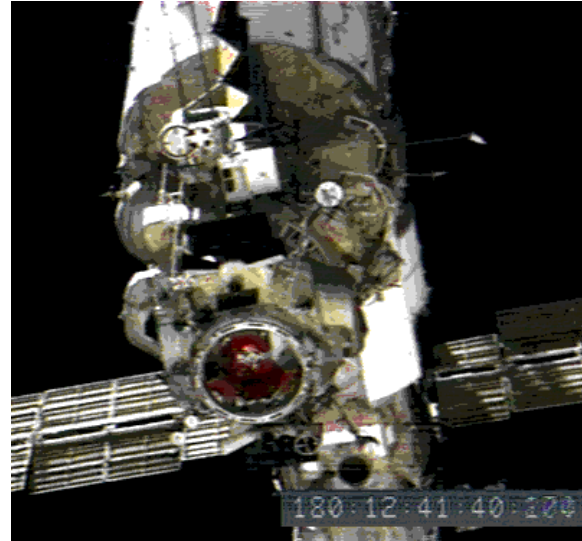
Figure 4-B PLB 'C' Approach View

The crew also used payload bay camera 'C' to view the Mir during the final stages of approach. Figure 4-B shows that camera 'C' imagery was not adversely affected by sun glare during this time period. The zoomed in field-of-view easily allowed identification of targets and docking mechanism details from over a hundred feet away.

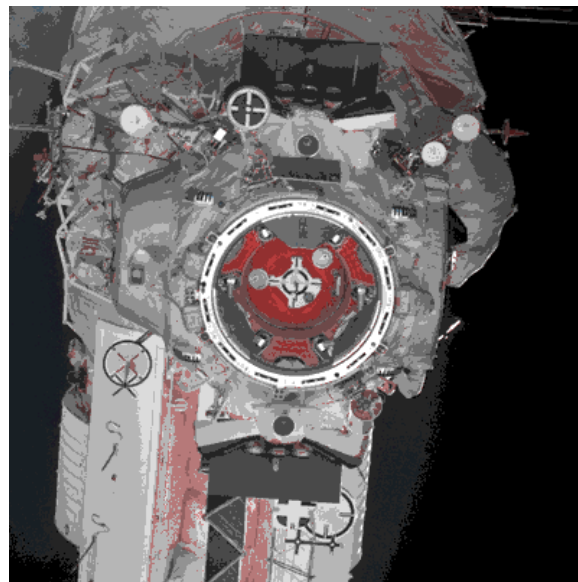
Figure 4-C Hasselblad Approach View

Hasselblad (70 mm) photography provided the best views of the APDU. The docking structural latches, capture latches, body-mounted latches, alignment guides, laser retroreflectors, fluid/electrical socket/plugs, and the old centerline target all appeared to be in good condition. Imagery acquired during backaway verified that the new centerline target was also in good condition.

The still photograph in Figure 4-C was obtained using the Hasselblad camera with a 250 mm lens. Since the vantage point for image acquisition was the flight deck overhead window, sun glare similar to that seen on the upward pointing ODS centerline video was also a factor in the still photography. Most of the post-mission analysis of the docking mechanism was performed from this imagery.

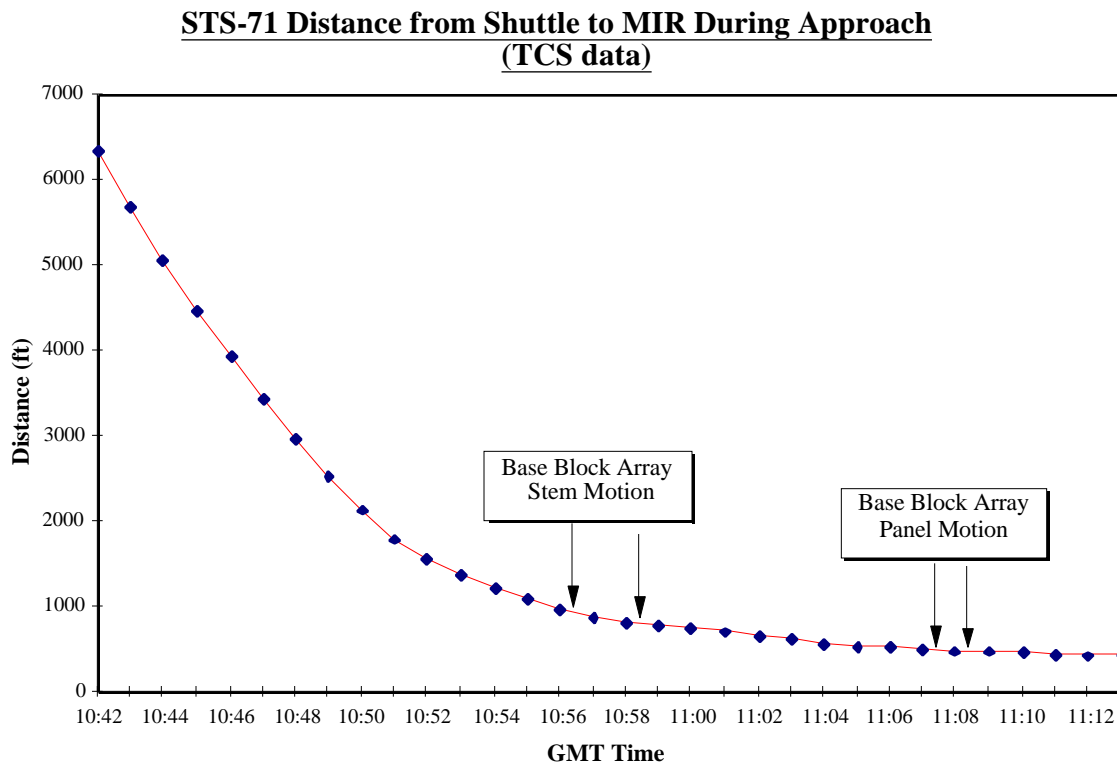
Figure 5-A Shuttle to Mir Distance During Stem / Panel Motion

Substantial motion of the Base Block solar arrays was visible during the early stages of approach as the Mir was changing orientation to prepare for docking operations. Figure 5-A shows the distance between the Mir and the Orbiter when the two different sequences of solar array motion were seen. Each pair of arrows refers to the start and stop times of observable motion.

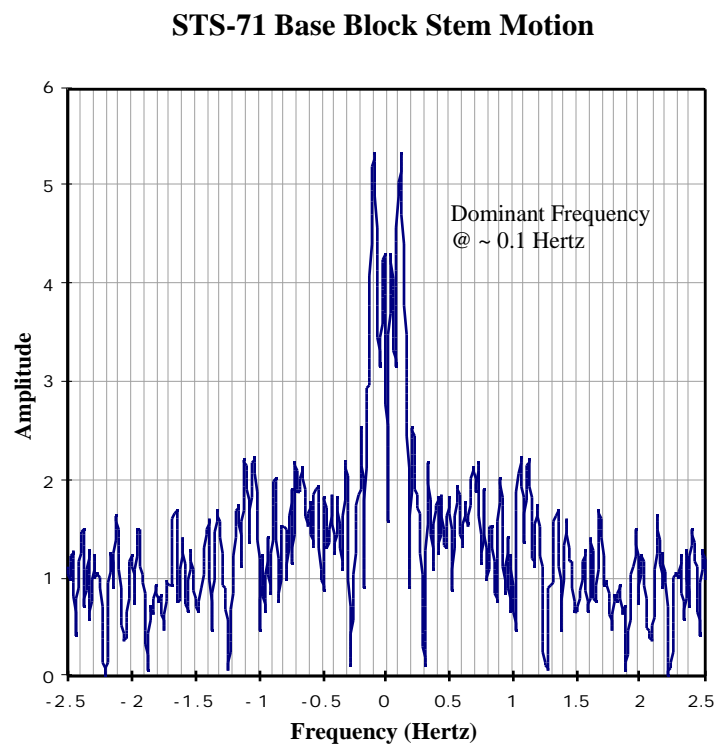
Figure 5-D Base Block Array Stem Motion Frequency

Figure 5-C shows this motion as a function of GMT time. Figure 5-D plots the corresponding frequency of oscillation. Analysis of this motion indicated a maximum peak-to-peak magnitude of about 24 inches (+/- 20%) and a dominant frequency of 0.11 Hertz.

Analysis of this data suggests that the Mir Base Block solar panel stems and arrays are in a location such that attitude firings do impinge upon them. There are other factors that could have contributed to this motion. Start and stop forces induced by rotating panels may have contributed to the first visible motion sequence. Additionally, during the latter part of this time sequence, it appeared as though all the other arrays continued to rotate while those on the Base Block appeared to stop.

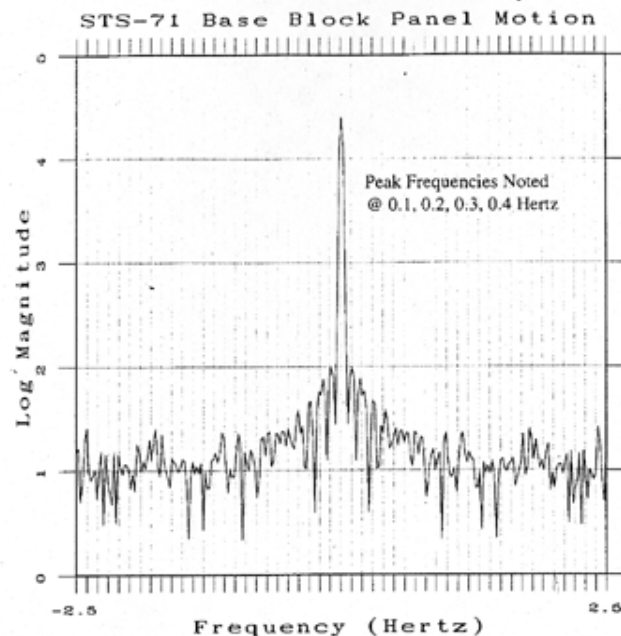
Figure 5-F Base Block Array Panel Motion Frequency

No dominant frequencies are apparent on the plot in Figure 5-F, although several minor peaks can be identified. The presence of these minor peaks at 0.2, 0.3 and 0.4 Hertz suggest that they may be harmonics associated with the peak at 0.1 Hertz.

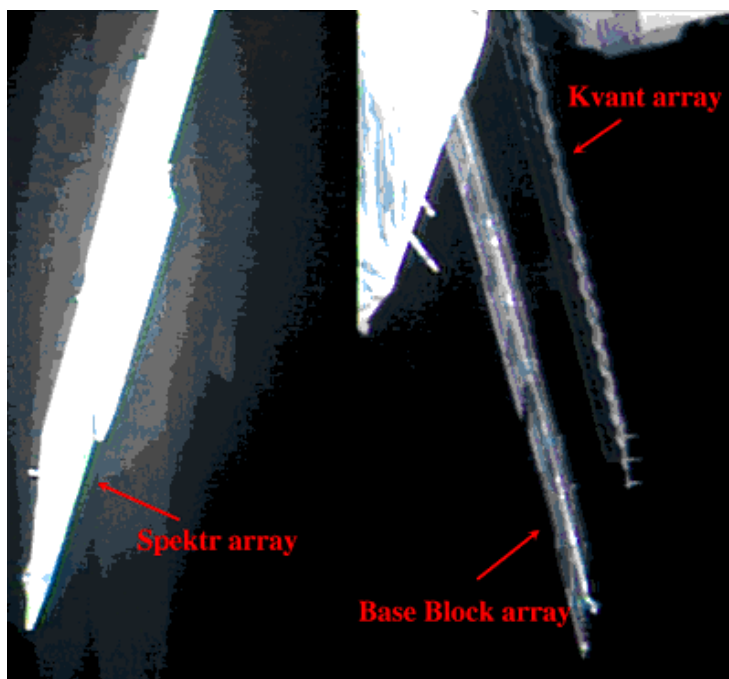
Figure 6-A Muxed Views of PRCS Test #7

A typical multiplexed view used in the analysis is shown in Figure 6-A.

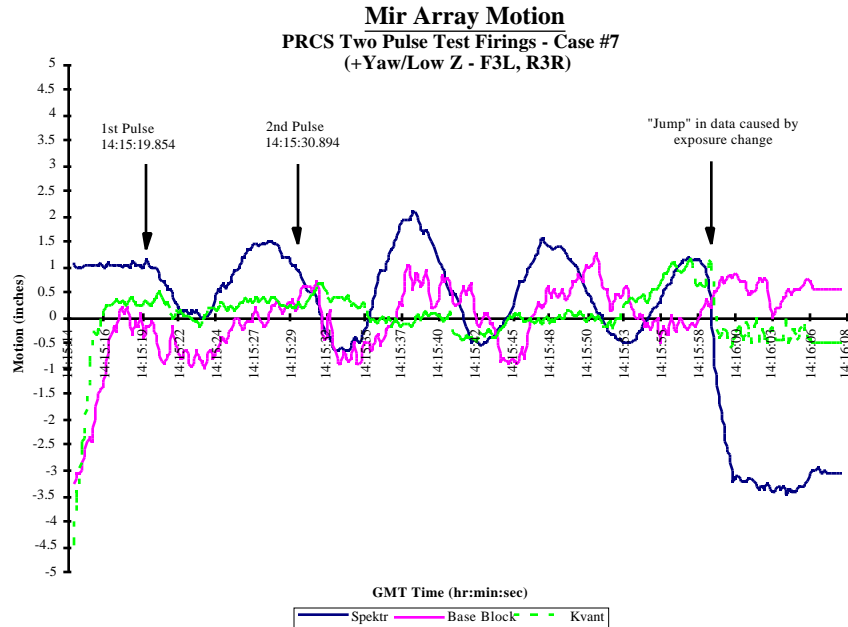
Figure 6-B Array Motion from PRCS Test #7

The following analysis was performed on PRCS Test #7. This data is shown in the accompanying plot in Figure 6-B. Analysis indicated that maximum motion of the Spektr array occurred just after the thruster firings and was on the order of 3 inches. Note that the motion appears to be in the form of a damped sinusoid. The data also implies the existence of a dominant frequency peak, which can be clearly seen in Figure 6-C.

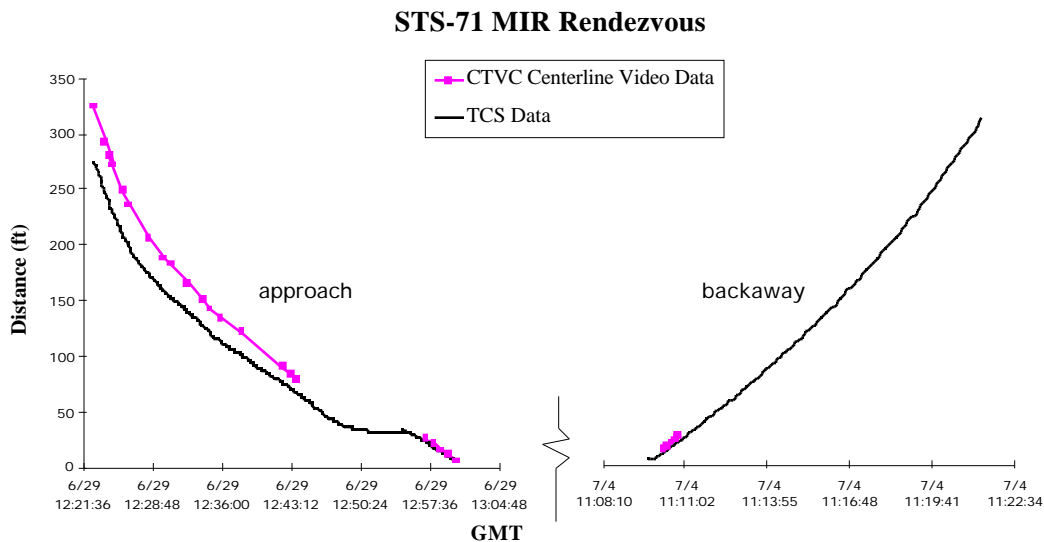
Figure 7-A Orbiter to Mir Distance using TCS and Centerline Video Data

Figure 7-A compares actual TCS data with that from the ODS centerline video camera. Camera distance calculations utilized horizontal-field-of-view (HFOV) information embedded in the vertical interval. The HFOV numbers have $\pm 1^\circ$ errors, and when propagated through photogrammetric equations, result in maximum errors of $\pm 20\%$. As seen in Figure 7-A, video data was not acquired through portions of the approach and backaway sequences.

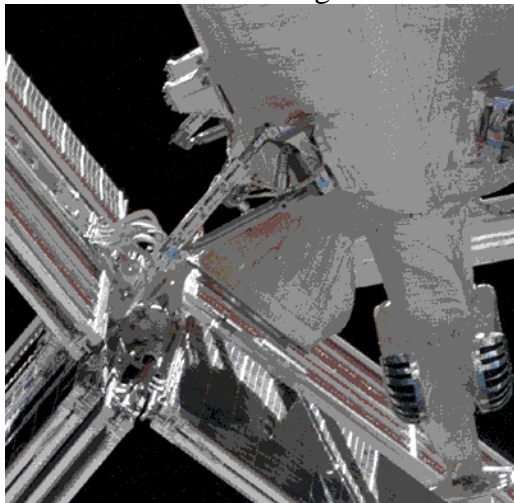
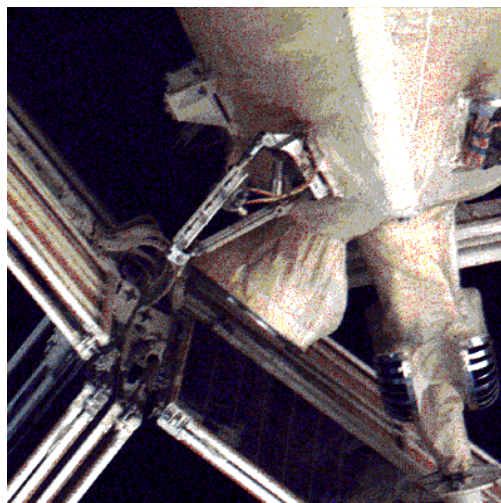
Figure 8-A Nikon view of Spektr Array Figure 8-B ESC view of Spektr Array

A subjective comparison of the images in Figures 8-A and 8-B indicate that the ESC, while suitable for quick look analysis, does not approach the resolution of the film camera. A more rigorous test may be conducted on a future mission as crew time and training procedures allow.
